Thank you for your interest in the Xilinx XC3S1400A FPGA device engineering samples. Although Xilinx has made every effort to ensure the highest possible quality, these devices are subject to the limitations described in this errata notification.

Table 1: XC3S1400A Devices Affected by These Errata

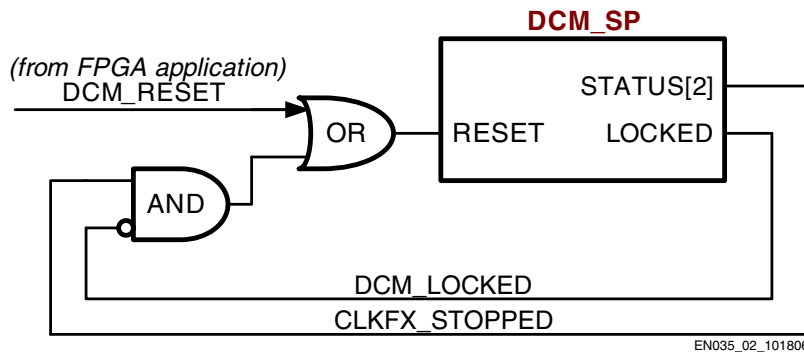
Figure 2: DCM DFS Lock Failure Workaround

A small number of DCM DFS locking failures have been observed during characterization.

A software workaround exists, as shown in [Figure 2](#). This circuit is automatically inserted by the ISE development software starting with version 9.1i. Using FPGA logic, the circuit monitors both the LOCKED output from the DCM_SP function and the STATUS[2] bit, which indicates that the DFS output CLKFX has stopped. If LOCKED = 0 and STATUS[2] = 1, then the circuit asserts the DCM RESET input. If the FPGA application also resets the DCM, then OR the reset signal from the FPGA application with the monitored output signals.
