AM335x ARM Cortex-A8 Microprocessors (MPUs)
Silicon Revision 1.0

Silicon Errata

TEXAS INSTRUMENTS

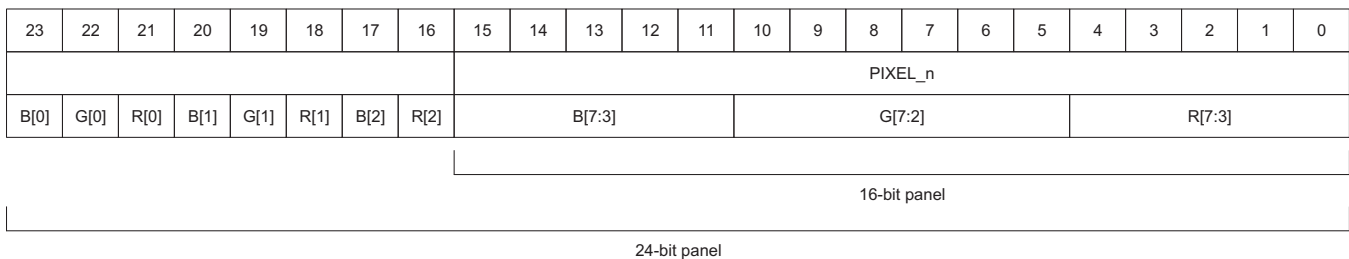
Figure 2. RGB888 Mode LCD Controller Output Pin Mapping (LCD_DATA[23:0])

The blue and red color assignments to the LCD data pins are reversed when operating in RGB888 (24bpp) mode compared to RGB565 (16bpp) mode. In order to correctly display RGB888 data from the SGX, or any source formatted as RGB in memory, it is necessary to connect the LCD panel as shown in Figure 2. Using the LCD Controller with this connection scheme limits the use of RGB565 mode. Any data generated for the RGB565 mode requires the red and blue color data values be swapped in order to display the correct color.

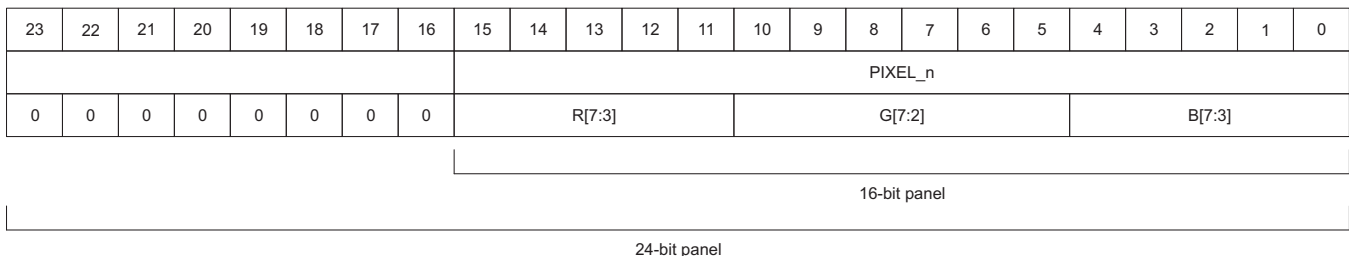
Figure 3. RGB565 Mode LCD Controller Output Pin Mapping (LCD_DATA[23:0])

When operating the LCD Controller in RGB565 mode the LCD panel should be connected as shown in Figure 3. Using the LCD Controller with this connection scheme limits the use of RGB888 mode. Any data generated for the RGB888 mode requires the red and blue color data values be swapped in order to display the correct color.
