# STM32F105xx and STM32F107xx Errata sheet

## STM32F105xx and STM32F107xx revision Z connectivity line device limitations

This errata sheet applies to the revision Z of the STMicroelectronics STM32F105xx and STM32F107xx connectivity line products. This family features an ARM™ 32-bit Cortex®-M3 core, for which an errata notice is also available (see [Section 1](#) for details).

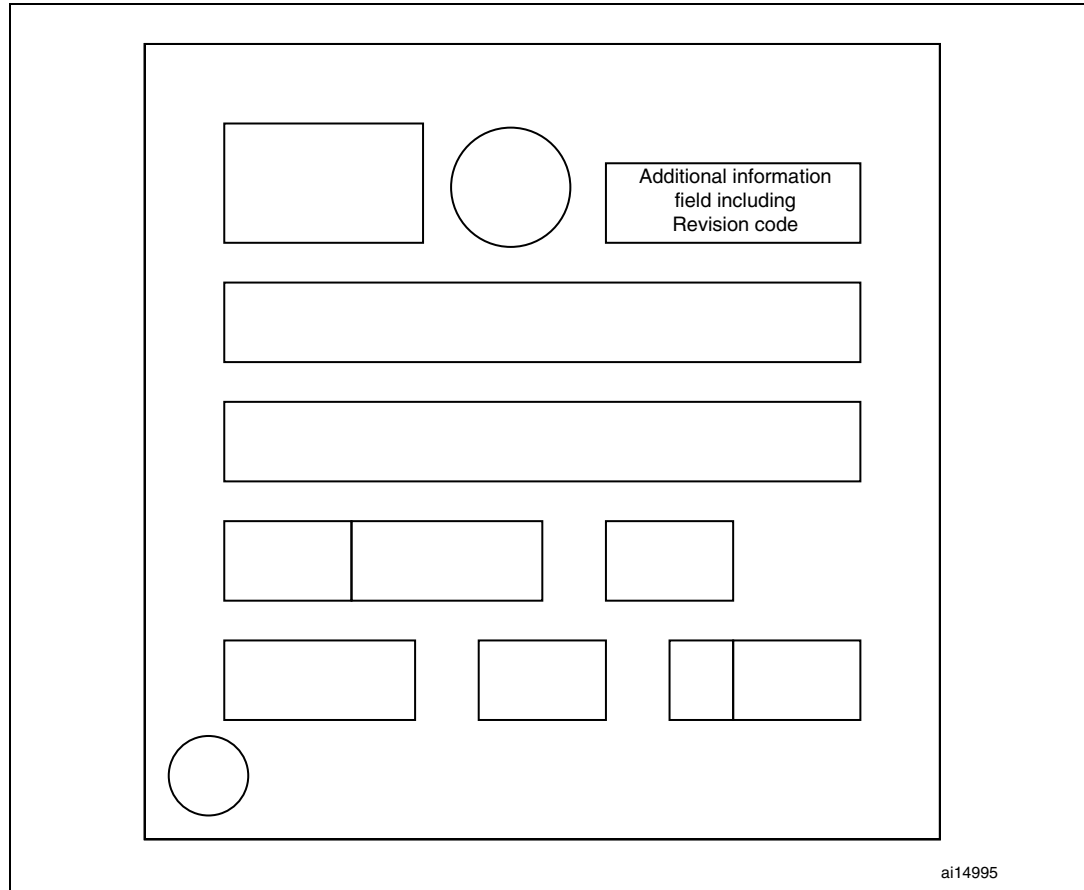
Figure 1. LFBGA100 top package view

Figure 1, Figure 2 and Figure 3 show the marking compositions for the LQFP100 and LQFP64 packages, respectively. The only fields shown are the Additional field containing the revision code and the Year and Week fields making up the date code.
