## W3150A+/W5100 Errata Sheet

Ver 1.0.0 (OCT. 27, 2007)	First release (erratum 1)
Ver 2.0.0 (SEP. 10, 2008)	Add W5100 solution for erratum 1
	Remove Recommendation for erratum 1
Ver 2.1 (APR. 5, 2010)	Remove the erratum solution for W5100 in
	v2.0 and bring back the recommendation of
	v1.0
Ver 2.2 (FEB. 17, 2012)	Add erratum 2, 3
Ver 2.3 (MAR. 5, 2012)	Add a solution for erratum 2, 3

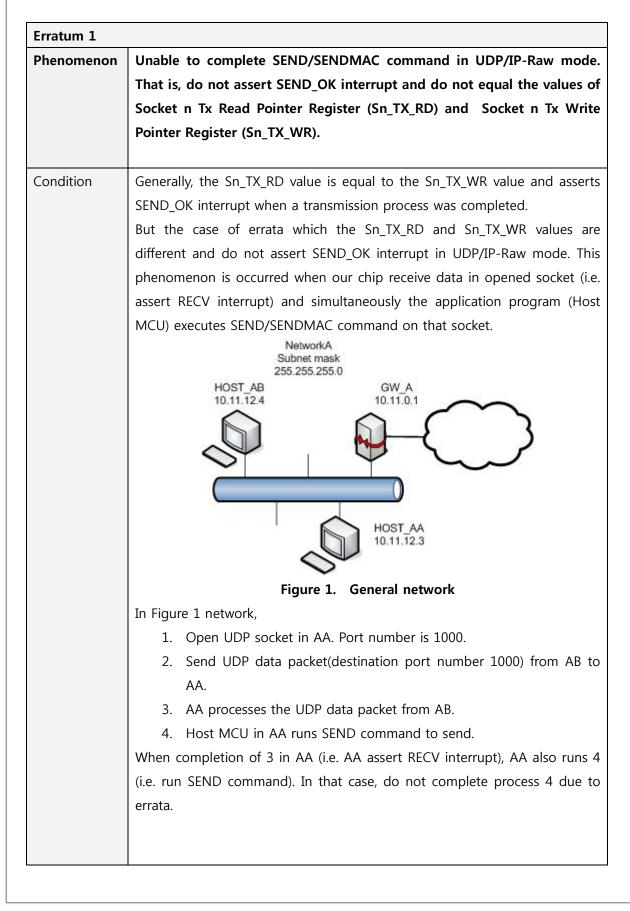
Solution	In case of W3150A+,
	If you can monitor the RXDV signal (in MII interface), you can solve this problem.
	Before you execute SEND/SENDMAC command in UDP/IP-Raw mode, check
	the value of RXDV signal is '0'. That means there is no received data packet,
	so you can avoid the errata condition.
	Refer to following pseudo-code.
	/* Change sendto() function */
	Function sendto()
	{
	While $(RXDV == '1')$ ;
	SEND command;
	/* Complete Sending */
	}
Recommendat ion	In case of W5100,
	We don't have solution but we can give a recommendation.
	After complete a transmission process, check whether Sn_TX_RD and
	Sn_TX_WR have same values or not. If both values are still different, close
	the socket and reset by force.
	/* Change sendto() function */
	Function sendto()
	{
	/* Complete Sending */
	/* wait until Sn_TX_WR and Sn_TX_RD are same */
	While (Sn_TX_WR != Sn_TX_RD)
	{
	wait some time;
	loop_cnt++;
	if (loop_cnt > CONST_BLOCK_CNT) goto RESET
