Introduction

Thank you for designing with the Xilinx Virtex®-6 family of devices. Although Xilinx has made every effort to ensure the highest possible quality, the devices listed in [Table 1](#) are subject to the limitations described in the following errata.

Hardware Errata Details

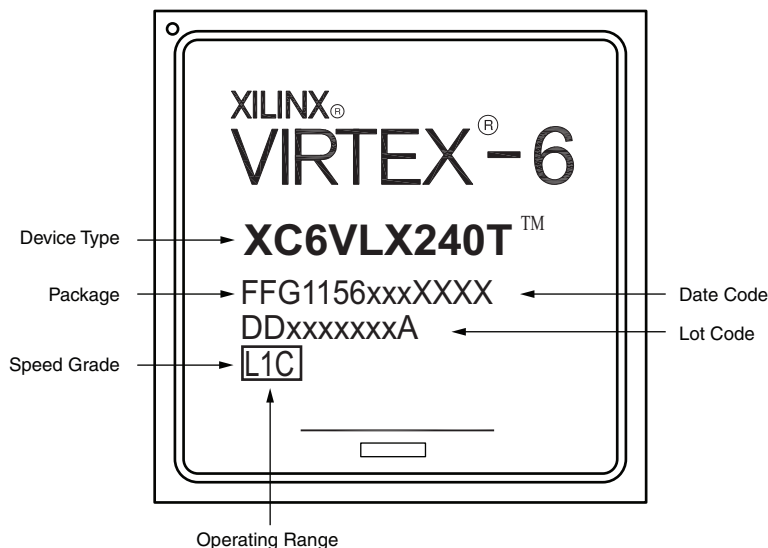
Figure 1: Example Device Top Mark

The XC6VLX240T is marked as shown in [Figure 1](#). The other devices listed in [Table 1](#) are marked similarly.
